# Case Study: Maintaining Irrigation Repairs at Hanging Rock Golf Club

BY JOHN ROBERSTON, KRAUSZ USA

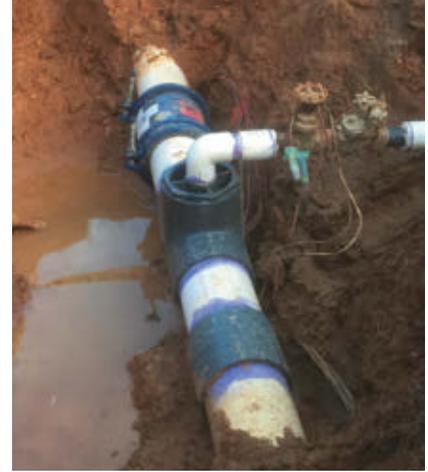
The HYMAX features a one-piece design to deliver fortified strength and enhanced flexibility, and has a fusion-bonded epoxy coating that insulates against corrosion with nuts, bolts and other components made of stainless steel. Advanced Molecular Anti-Galling (MAG) provided a unique dry treatment process on nuts and bolts, based

on embedded zinc, to prevent galling and enable repeated bolt tightening. The anti-galling also eliminates the need for grease, preventing dust and dirt build-up.
